Office-Shop

Review conducted January 2012 using 2010 ADA Standards for Accessible Design.

Areas of Non-Compliance & Recommendations

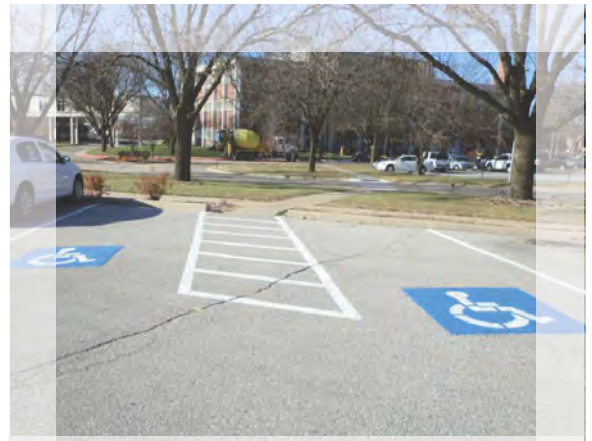
Image 50

- 0-882 Slope and cross slope of both accessible parking spaces and access aisles in employee parking lot B greater than allowed by ADA Design Standards (parking spaces' slope/cross slope- 3.5% / 3.5%, access aisles' slope/cross slope - 4.4% / 4.5%). Changes in level are not permitted at parking spaces and access aisles adjacent to them. Access aisles shall be at the same level as the parking spaces they serve. [ADA Sections 302 and 502.4] (See Image 50).

- 0-883 No signage identifying reserved spaces in employee parking lot B as accessible parking. Parking spaces complying ADA Design Standards shall be identified by signs. [ADA Sections 216.5, 502.6, and 703.7.2.1] (See Image 50).

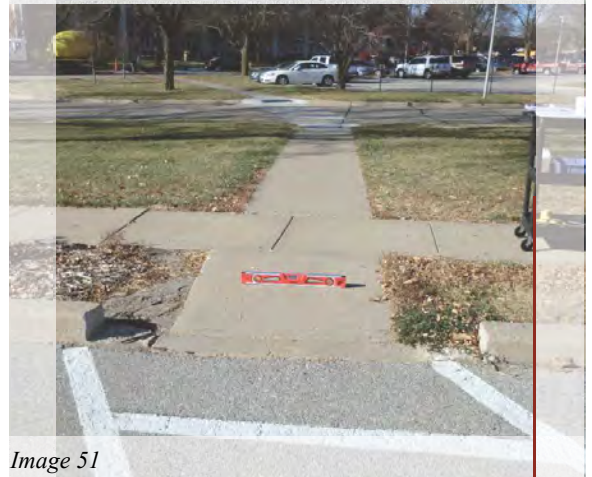
Image 51

- 0-884 Sidewalk connecting access aisle at accessible parking spaces in employee parking lot B to accessible route has non-compliant cross slope (3.0%). The ADA has determined that a cross slope of greater than 1:48 can impede forward progress and compromise control and balance. [ADA Section 403.3] (See Image 51).

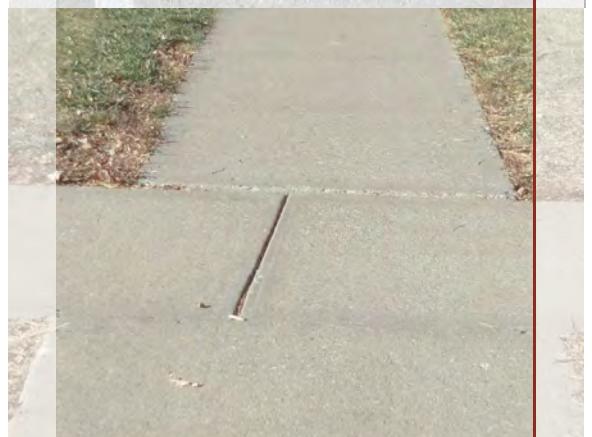
Image 52

- 0-885 Transition from sidewalk at access aisle at accessible parking spaces in employee parking lot B to accessible route hindered by changes in level on both sides of intersecting sidewalk. Changes in level of 1/4 inch high maximum shall be permitted to be vertical. Changes in level between 1/4 inch high minimum and 1/2 inch high maximum shall be beveled with a slope not steeper than 1:2. [ADA Section 303] (See Image 52).

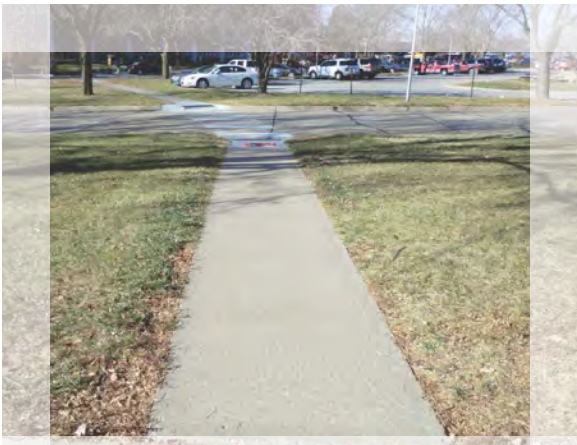
Image 54

- 0-887 Entire sidewalk to curb ramp 18 has non-compliant cross-slopes (3.0% to 4.5%). The cross slope of walking surfaces shall not be steeper than 1:48 (2%). The ADA has determined that a cross slope of greater than 2% can impede forward progress and compromise control and balance. [ADA Section 403.3] (See Image 54).

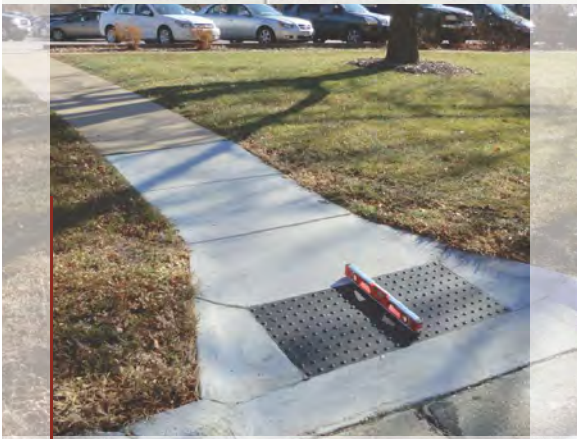
Image 55

- 0-889 Slope of curb ramp 18 greater than allowed (10.5%). In existing sites, ramps shall be permitted to have running slopes up to 1:10 (10%) where such slopes are necessary due to space limitations. Otherwise, curb ramps shall have a running slope no steeper than 1:12 (8.33%). [ADA Section 405.2] (See Image 55).

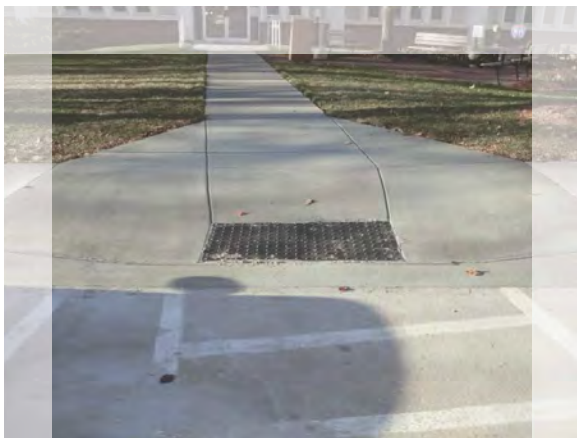
Image 62

- 0-180 Westernmost flared side of curb ramp 14 steeper than allowed by ADA Standards (14.8%). Curb ramp flares shall not be steeper than 1:10 (10%). [ADA Section 406.3] (See Image 62).

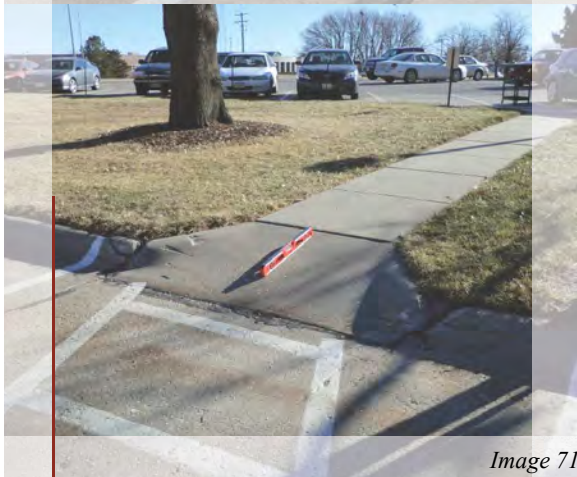
0-004 Slope of curb ramp 19 greater than allowed (18.7%). In existing sites, ramps shall be permitted to have running slopes up to 1:10 (10%) where such slopes are necessary due to space limitations. Otherwise, curb ramps shall have a running slope no steeper than 1:12 (8.33%). [ADA Section 405.2] (See Image 71 and recommendation on page 18).

- » *Recommendations: Remove and replace curb ramp so that it meets ADA Design Standards.*

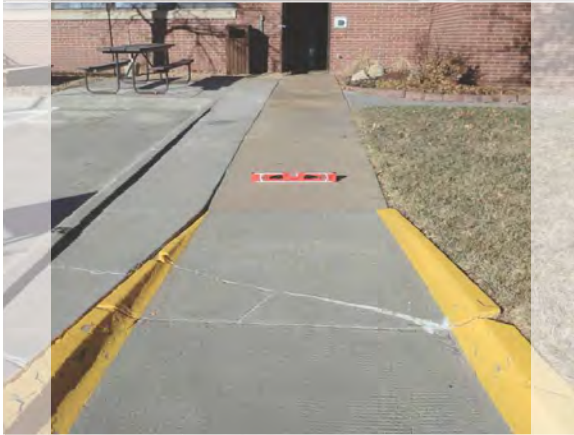
Image 75

- 0-008 Broken surface on curb ramp 21 hinders stable and firm accessible route. Disabled visitors may lose balance or be unable to maneuver mobility aids due to changes in elevation and uneven surfaces. [ADA Sections 206, 302, and 402] (See Image 75).

- 0-007 Cross slope of portions of sloped sidewalk from curb ramp 21 to intersecting sidewalk greater than allowed by ADA Design Standards (2.6% to 3.5%). The ADA has determined that a cross slope of greater than 1:48 can impede forward progress and compromise control and balance. [ADA Section 403.3] (See Image 75).

- 0-009 No level landings at tops of curb ramps 19, 20, and 21. Landings must be provided at the tops of curb ramps with clear widths at least as wide as the curb ramps, excluding flared sides. [ADA Section 406.4] (See Images 75, 76, and 77 on page 19).

- » *Recommendation: Remove and replace areas of sidewalks so that cross slopes are 1:48 or less (approximately 8 linear feet).*

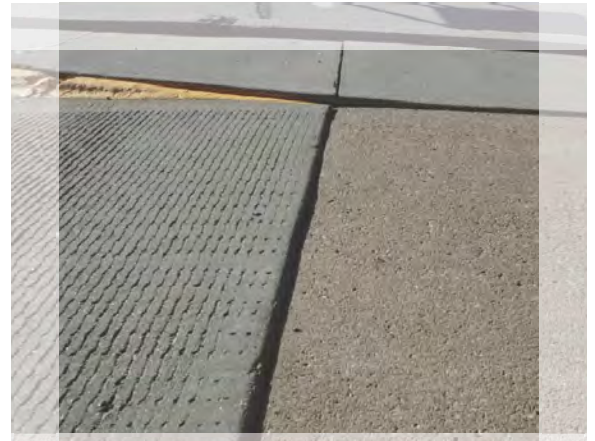
- 0-012 Transition between top of curb ramp 21 and sloped sidewalk contains change in level due to heaving, settling, or dislodging of joint caulking. Changes in level greater than 1/2 inch along both accessible routes to main entrance doors. Changes in level of 1/4 inch high maximum shall be permitted to be vertical. Changes in level between 1/4 inch high minimum and 1/2 inch high maximum shall be beveled with a slope not steeper than 1:2. [ADA Section 303] (See Image 78 on page 19).

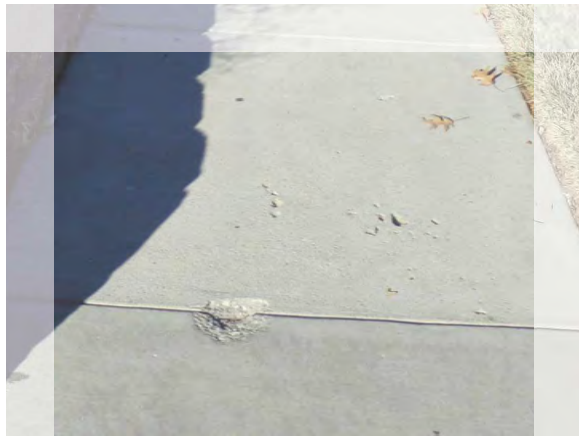
Image 82

- 0-010 Broken surface and holes on sidewalk leading to public entrance of building hinders stable and firm accessible route. Disabled visitors may lose balance or be unable to maneuver mobility aids due to changes in elevation and uneven surfaces. [ADA Sections 206, 302, and 402] (See Image 82).

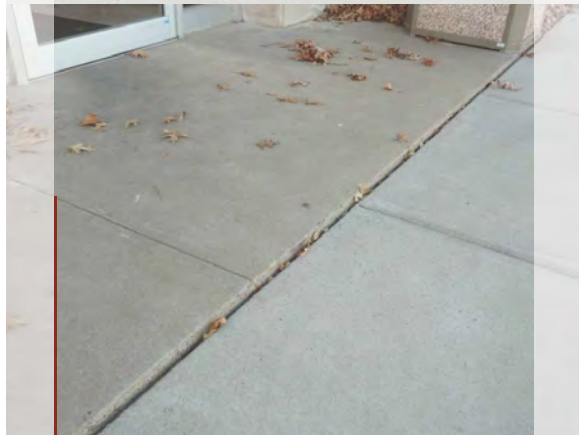
Image 83

level of 1/4 inch high maximum shall be permitted to be vertical. Changes in level between 1/4 inch high minimum and 1/2 inch high maximum shall be beveled with a slope not steeper than 1:2. [ADA Section 303] (See Image 83).

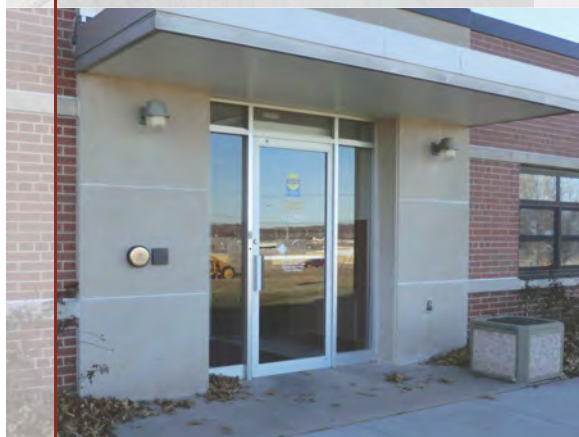
Image 84

- 0-013 Inadequate maneuvering clearance at public entrance door due to change in level at transition between sidewalk and landing at door (58 inches). Maneuvering clearance of 60 inches perpendicular to the pull side of a door must be provided for a forward approach. [ADA Section 404.2.4] (See Image 84).
